DMRE PRESENTATION ON DERELICT AND OWNERLESS MINE

19 SEPTEMBER 2019

Department of Mineral Resources and Energy

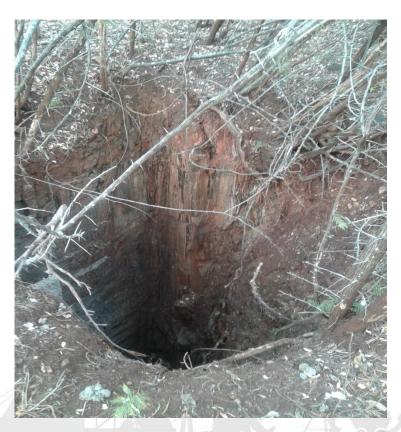
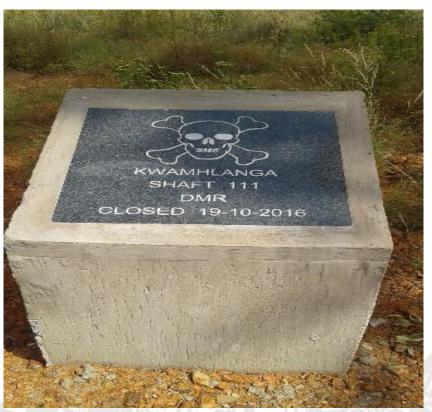
Holings Pictures

Kwa-Mhlanga dangerous mine opening

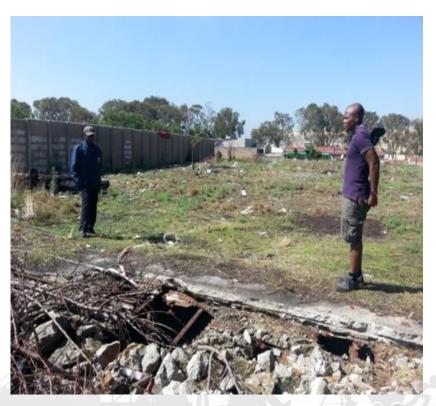
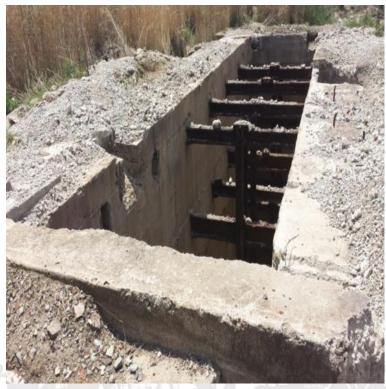
Holings Pictures

DANGEROUS ABANDONED GOLD MINE SHAFTS IN GAUTENG

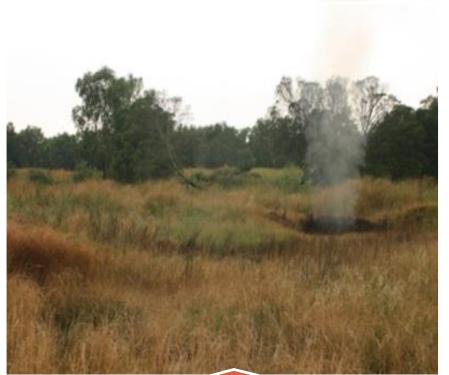
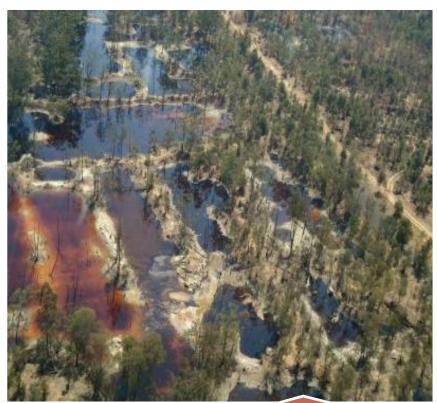
Key environmental challenges due to past coal mining activities at Emalahleni in Mpumalanga

Underground coal fires

Acid mine drainage in old workings

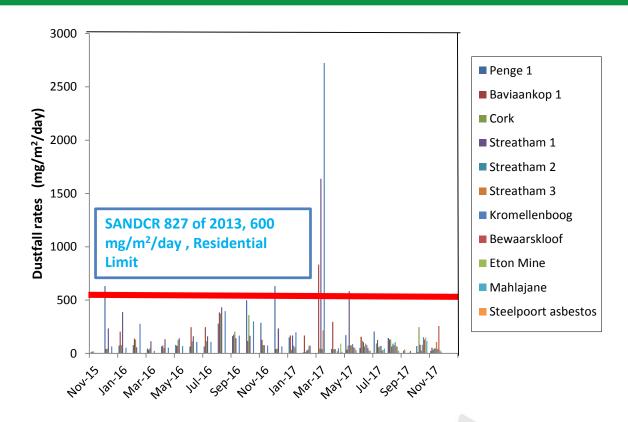
Air Quality Monitoring

Dust-fall rates at sites in the Limpopo Province.

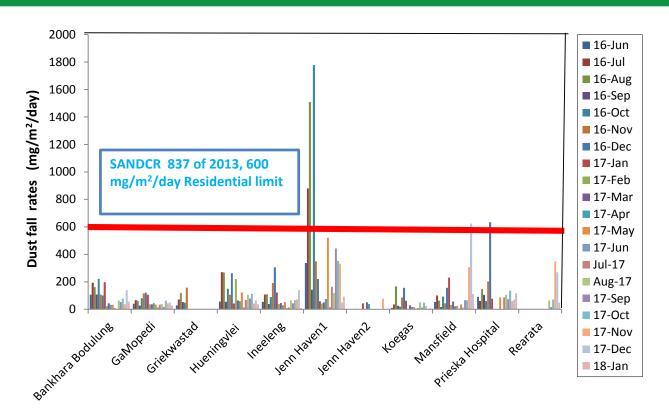
Air Quality Monitoring

Dust-fall rates in the Northern Cape Province.

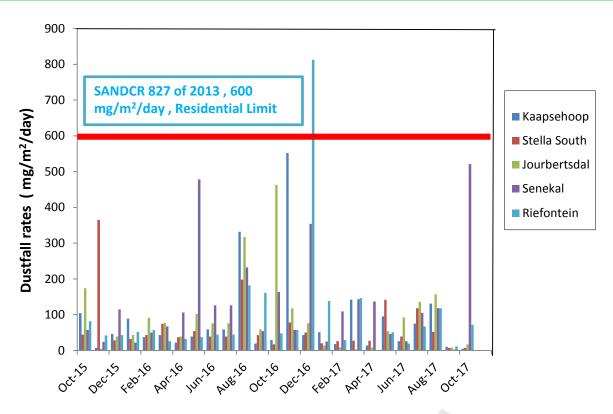
Air Quality Monitoring

Dust-fall rates in the Mpumalanga Province.
