REMEDIATION OF ARSENIC IMPACTED SOILS WITH FERROUS SULFATE

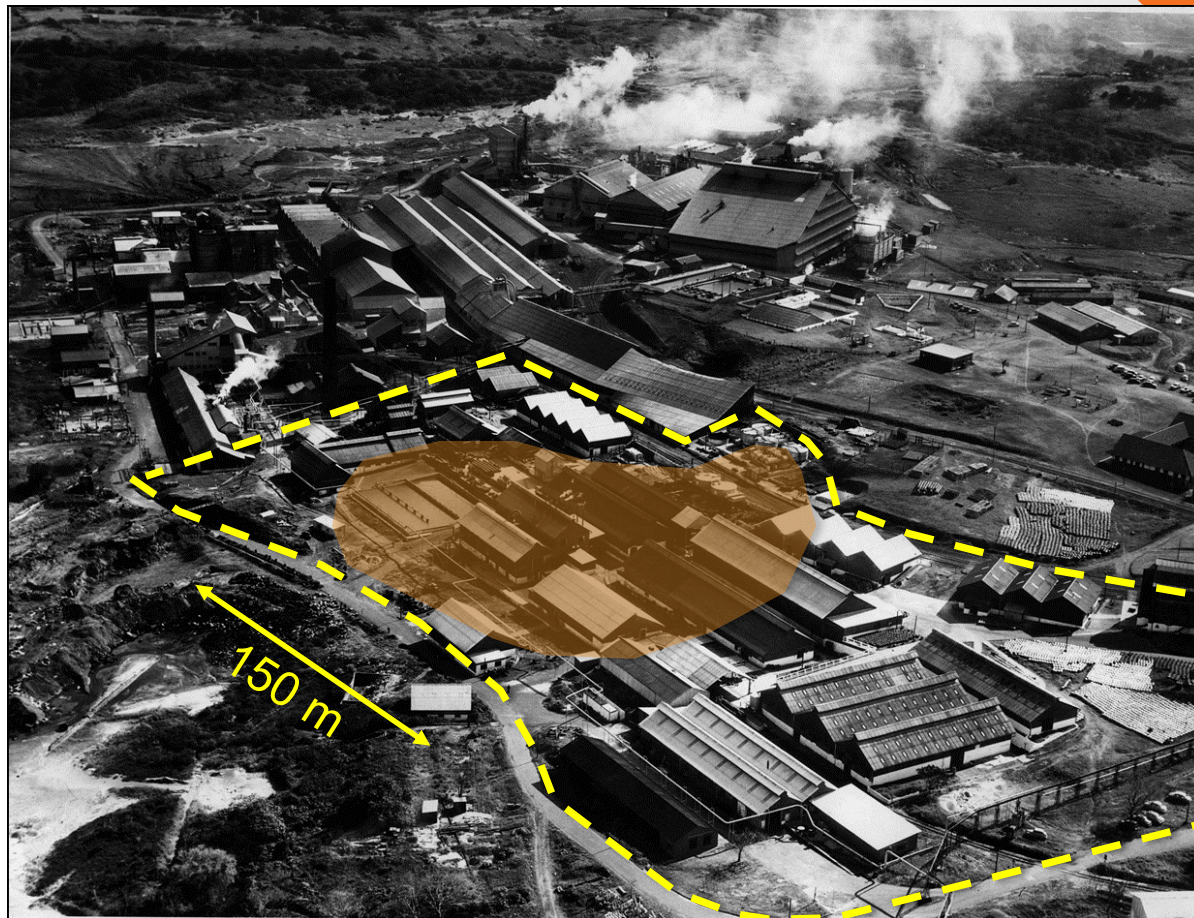
Demolition Interventions 2006- 2008

- Buildings demolished
- As hot spots removed
- Soils treated with 5% ash and 5% Lime; BP
- Area profiled, compacted to reduce infiltration
- 2 Platforms created
- Released to Landlord

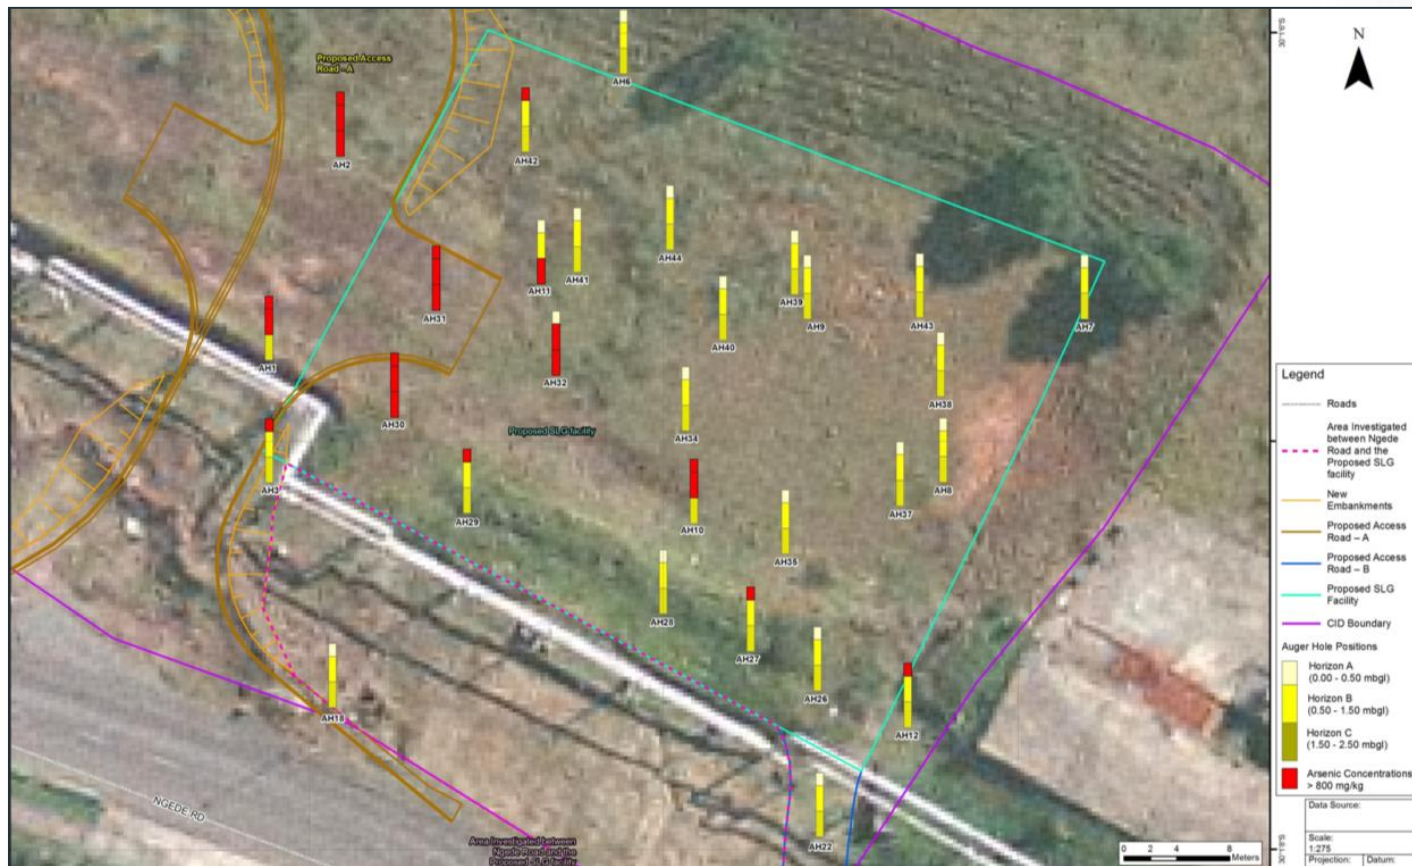
- Hotspot removal based on portable XRF analyzer results
- Excavation and stockpiling of arsenic impacted soils (625 m³)
- Remediation of the remainder of the development footprint and the stockpiles would follow suit

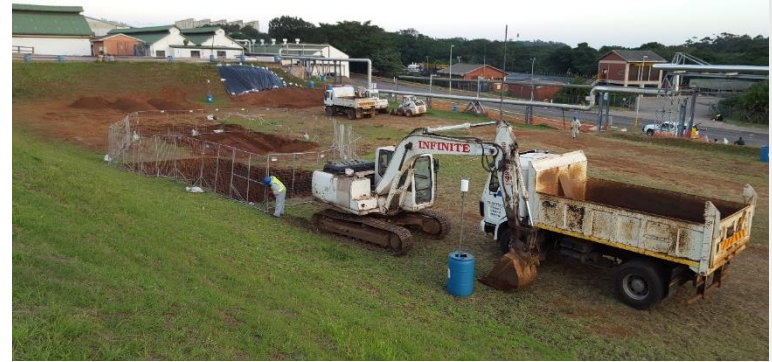
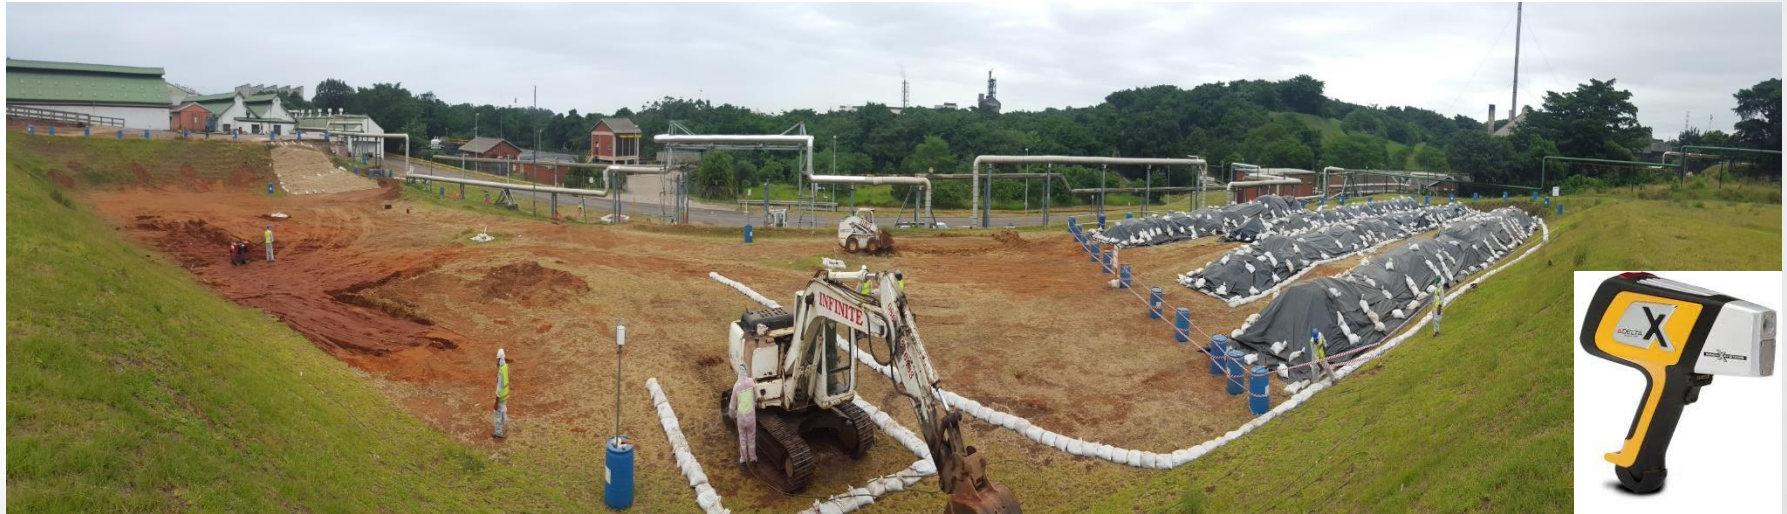
- The site is located approximately 1km inland
- It is underlain by about 30m of clayey Berea Red Sands - high iron content - assisted with natural attenuation
- Fractured tillite occur beneath the sands
- As releases over time exceeded natural attenuation capacity beneath – impacted groundwater (15mbgl)
- Groundwater impacts are localized beneath the site, rapidly decrease in concentration down gradient
- Main Risk drivers: surface water resource (stormwater channel); groundwater resource (potential use unlikely); direct exposure

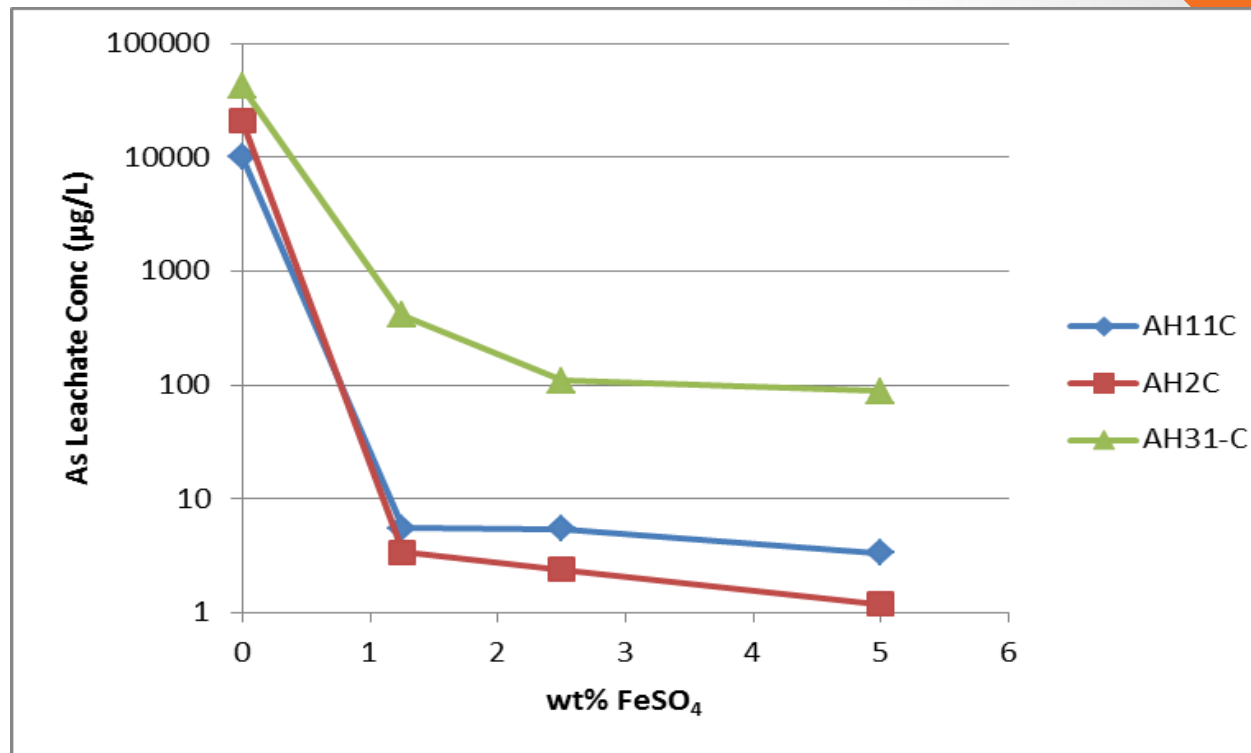
- 5 x 5 m x 1.5 m deep field trial
- Treated @ 2.5 wt.% ferrous sulfate
- Resampled after 1, 2 and 5 weeks
- 90 and 99% reduction in leachate As

- Trails confirmed: ferrous sulfate effective in significantly reducing arsenic leachability
