# NATIONAL ASBESTOS MANAGEMENT STRATEGY FOR SOUTH AFRICA

## Project Update

Asbestos and Land Remediation Workshop

12 March 2020

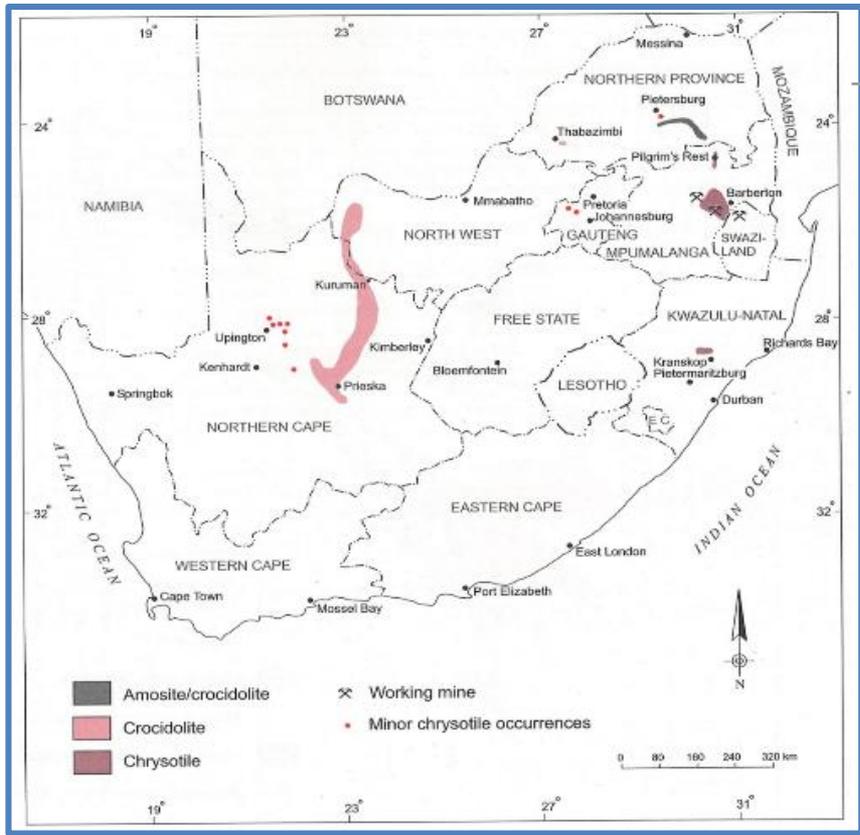
Location of main asbestos fields in South Africa  
Source: (Wilson & Anhaeusser, 1998)

## Asbestos Reserves Scattered across SA

Major reserves in Northern Cape, Limpopo and Mpumalanga Provinces

Few reserves in North West and Gauteng

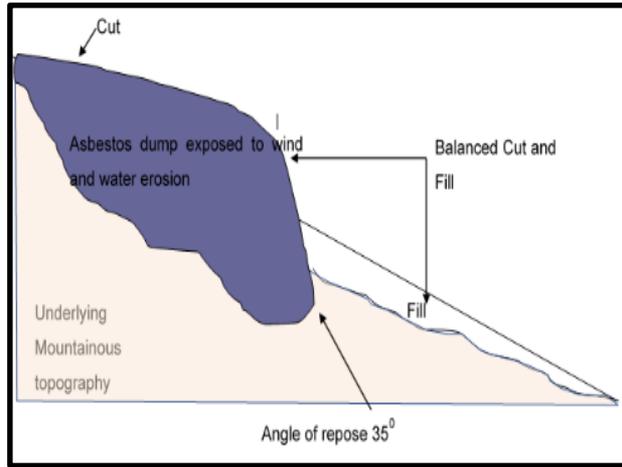
## Step 1: Grading and Shaping

Grade and shape the heap to an acceptable angle. Alternatively: If the topography allows it, dig trenches and fill the trench with asbestos residue

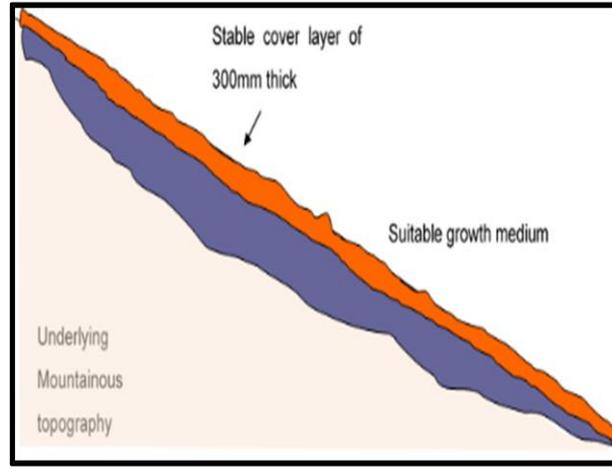
## Step 2: Apply Cover Layer

Cover the heap with 300 – 500mm clean soil;

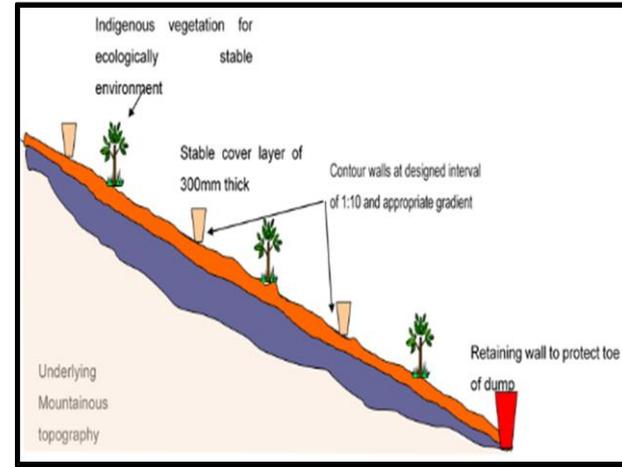
## Step 3: Erosion Control

Construct appropriate erosion control measures; and Establish vegetation that naturally occur in the area on the topsoil covered heap

Best Practice to rehabilitate exposed asbestos dump

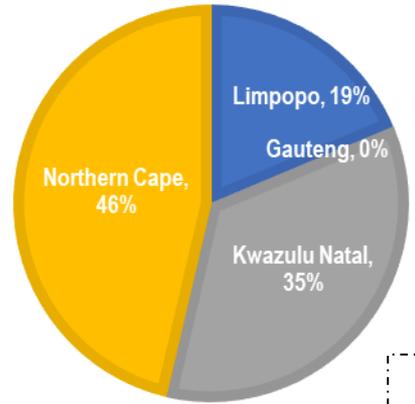
## % of Provincial Mine Rehabilitation Status

21% (out of 215) of asbestos contaminated mine in South Africa are deemed completely rehabilitated  
 6% are partially rehabilitated  
 14% of sites are classified as mine sites with no visual indication that mining has ever occurred  
 61% of Sites still to be rehabilitated  
 A timeline must be considered to conduct and finalize rehabilitation at the remaining sites

■ Limpopo ■ Gauteng ■ Kwazulu Natal ■ Northern Cape

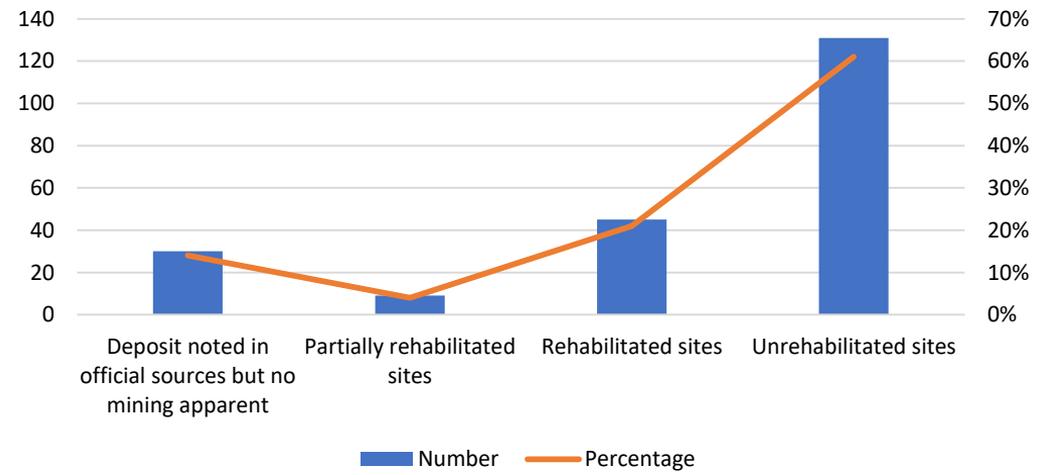
## Mine Deposits with Potentially Exposed Asbestos

### Breakdown of Asbestos Sites in various states of rehabilitation

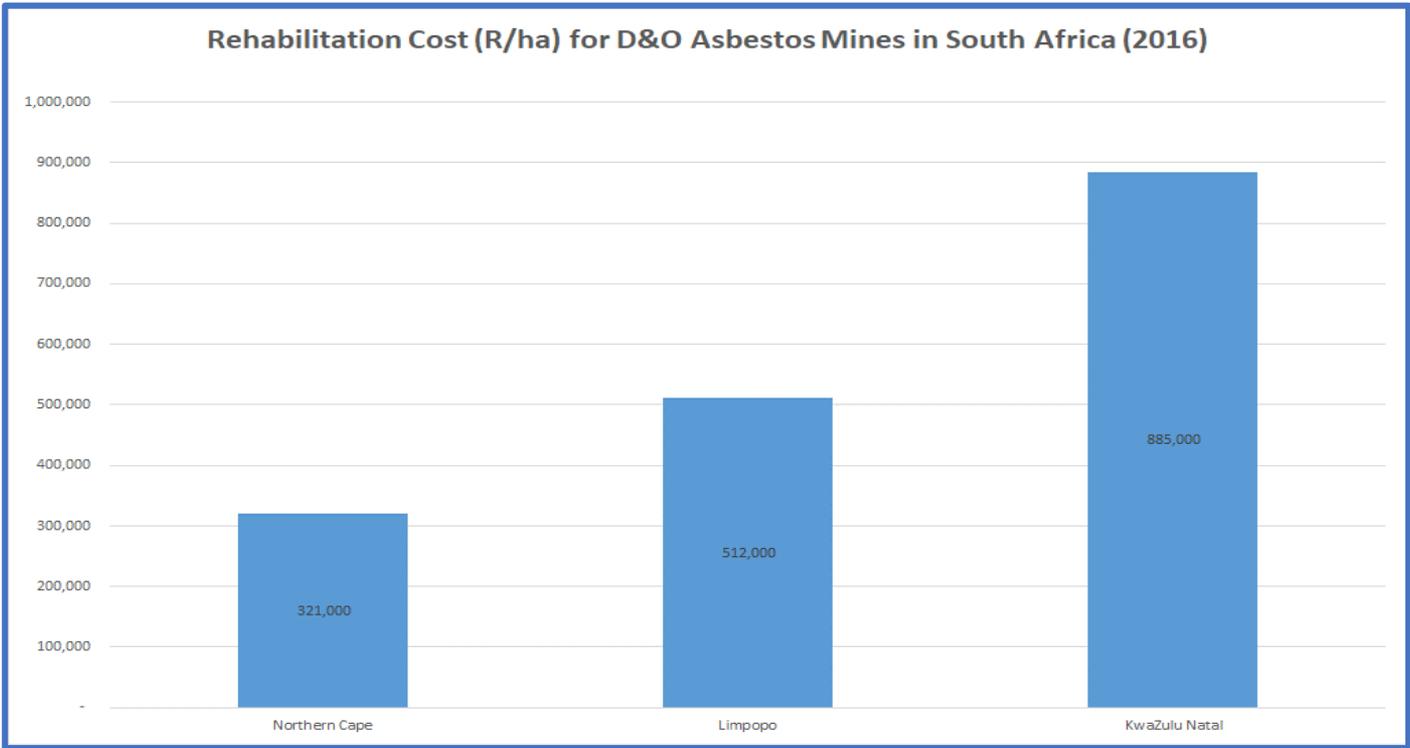
**Rehabilitation Cost for Derelict and Ownerless Mines in South Africa (Source: Mintek)**

The cost to rehabilitate disturbed mines varies due to different factors such as size of land and extent of contamination. A large disturbed area can benefit from economy of scale and being able to be rehabilitated using capital equipment, might be done at a lower cost and even with less labour.
